# Fletching Mill - What are your views?

## The Site

Fletching Mill lies on the Sussex Ouse, approximately 15km east of Haywards Heath, as shown in Figure 1 below. The site has a long history of engineering, including river modification for milling and navigation. The mill has now been demolished, and the old lock replaced by contemporary sluice gates in order to retain historic upstream river levels. A concrete fish ladder has also been built alongside a weir on the existing bypass channel. The current configuration is shown in the annotated sketch at Figure 2 overleaf.

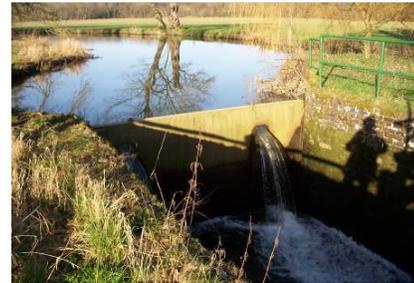
Fletching Mill – steel plate installed at site of collapsed sluice gates to maintain upstream water levels

Temporary repair works have been carried out by fixing a large steel plate upstream of the old locks, diverting some flow through the bypass channel, as shown in the following photograph.

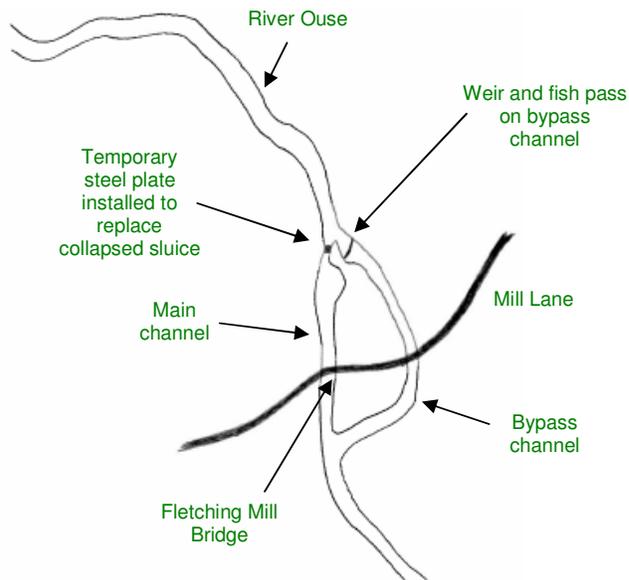
Figure 2: Fletching Mill – Current configuration

Weir – partial collapse

Fish pass

Temporary steel plate replacing collapsed sluice gates

Bypass channel

Main channel

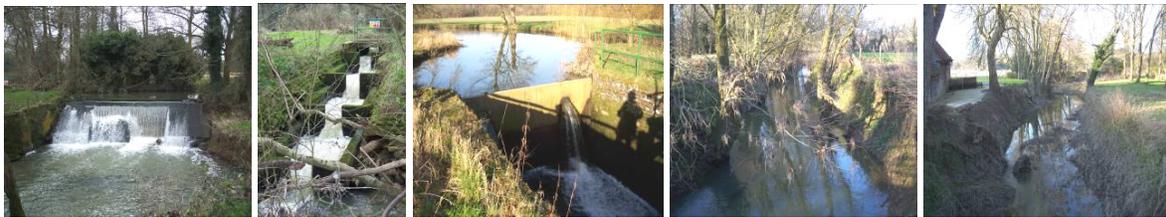
**Re-grading of the bypass channel** – through the construction of a series of stone 'riffles' in the bed of the river channel. The water level would gradually be raised to a height equivalent to that of the existing weir at the head of the bypass channel. Four or five riffles may be required between the bridge at the downstream extent of the restoration reach and the head of the bypass channel.
